# Did You Know?

## Water Intrusion and Premature Coil Failure (IC414)

### Coils and Water Don't Mix!

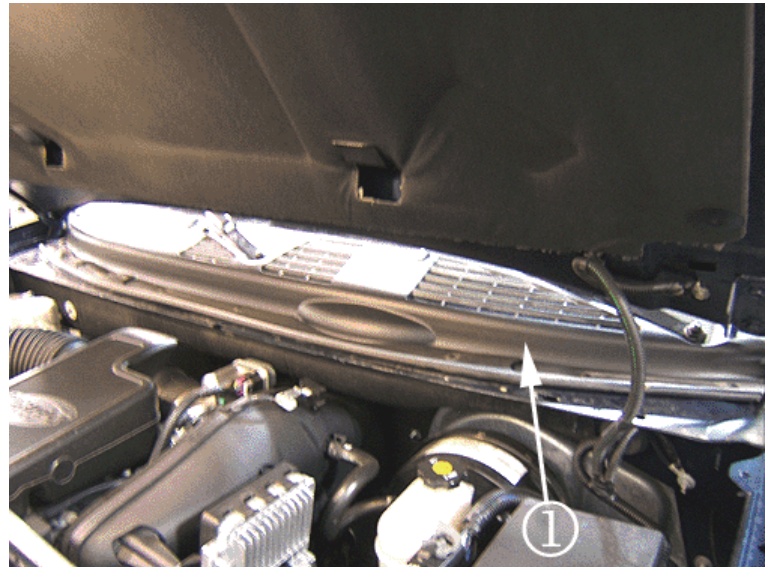
If a customer complains of a rough idle and/or the MIL/SES light flashes on after a rain shower or carwash, this may

indicate water intrusion. Check for possible DTC

codes P0300 through P0306 and inspect the coils and spark plugs. If upon inspection of the coils, a white chalk like build-up on the inside and/or outside of the spark plug boots is detected, the coils have been damaged and must be replaced—NAPA Echlin hi-quality IC414 coils should be installed.

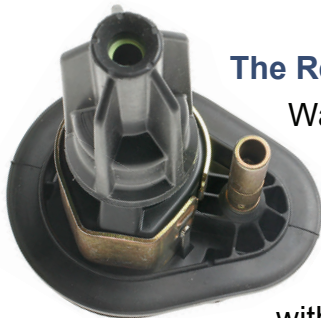
Water can seep past the engine cam cover and collect below the coils in the spark plug wells of the cylinder head resulting in a possible misfire. To prevent this from reoccurring, the AIP seal must be replaced with a replacement seal that redirects the water away from the engine cam coverer.
