TECH TIPS

CAM SENSOR PROBLEMS

- Chrysler Cirrus 2000
- Dodge Neon 1997-2005
- Dodge Stratus 1997-2000
- Plymouth Breeze 1997-2000
- Plymouth Neon 1997-2001

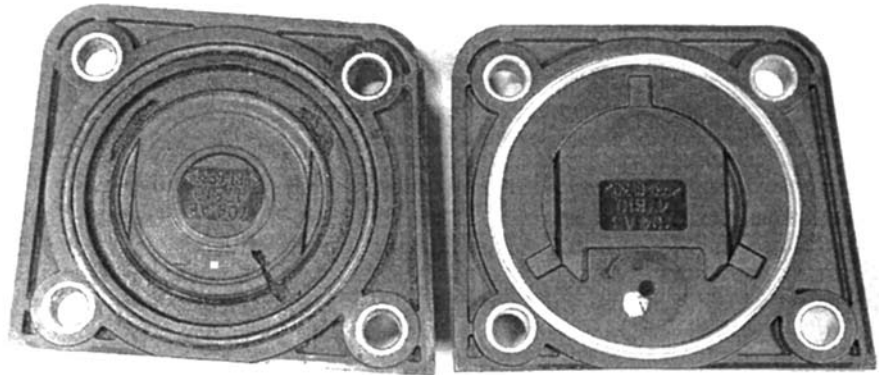
The cam sensor on these models with the 2.0L engine is located on the back of the cylinder head and at the end of the camshaft. What happens on these engines is the camshaft bearings in the head will become worn. This wear will create excessive camshaft end play. Maximum allowable is .013 inch. When the end play is greater than that, one of two things will happen. Either the camshaft will actually start to contact the sensor and eventually damage the sensor, or, the air gap between the cam ring and the sensor will be too large, causing a misfire or no start condition. In the situation where the camshaft has actually hit the sensor, it may actually be so far out that you may think that the replacement sensor is incorrect because you cannot install it. In the situation where the camshaft is too far in, then it may appear that there is no cam sensor signal, leading you to believe the sensor is bad. However, when you replace it with a new one, the same symptom is present. When you run across one of these vehicles that exhibit symptoms that lead you to the cam sensor, the first order of business is to check the camshaft end play before replacing anything. If the cam sensor already shows sign of contact, then you know that the cam end play is out of specification (.005-.013 inch). That must be corrected otherwise a new cam sensor may not be the answer to the problem. Refer to diagram #1.

Damaged by Camshaft

Good Sensor

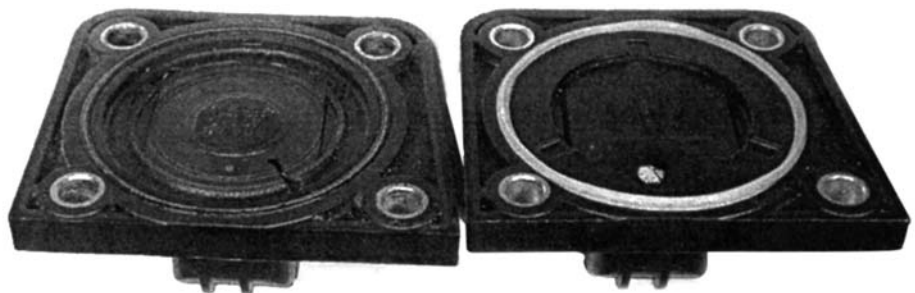
Damaged by Camshaft

Good Sensor
