Don't Get PO'ed With P0401 Codes

Ford P0401 Issues

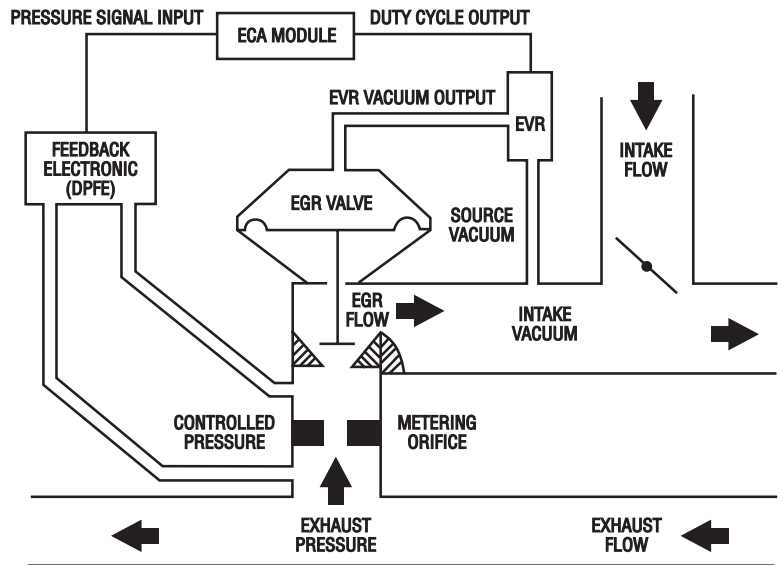
System Diagram

The Ford EGR Pressure Feedback system is known for persistent P0401 EGR low flow code issues. Bear in mind, low flow can be caused by several issues.

To prevent a recurrence of the P0401 code, NAPA Echlin recommends replacing the EVR and DPFE hoses when replacing the DPFE sensor. To further ensure the repair, also perform a de-carbonization treatment of the EGR system to prevent the re-occurrence of a P0401 code.

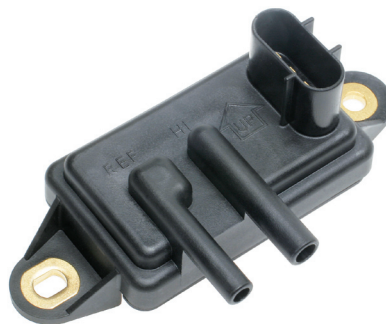
DPFE Sensor
2-19200

The most common issue is the failure of the EGR Pressure Feedback sensor commonly known as the DPFE sensor. If the diaphragm in the sensor becomes weak or the sensor is contaminated with moisture it can fail to supply the computer with the correct reference voltage. When this occurs, the computer increases the vacuum supply to the EGR valve causing the vehicle to run poorly. When the low flow signal is unable to be corrected by the computer's adjustment, then the computer sets a P0401 code for EGR flow.

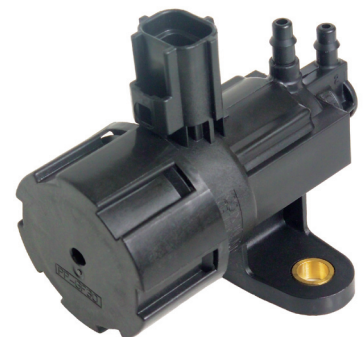
EVR
2-3001

The other parts that commonly get overlooked are the EGR Valve Regulator (EVR), which is cataloged as an EGR control solenoid, the DPFE hoses, and carbon build-up inside the EGR system. The EVR is responsible for supplying the proper vacuum to the EGR valve. Any resistance in this control circuit or failure of the EVR can cause a P0401 code. The original DPFE hoses are a special high-temperature hose. These hoses can crack or collapse internally over time due to intense thermal cycling that takes place within the EGR system. Replacement hoses are available in pre-cut sections from NAPA as a BK part number 700-2506.
