Did You Know?

NAPA ECHLIN FUEL INJECTORS OFFER THE QUALITY AND RELIABILITY ESSENTIAL FOR TODAY'S ADVANCED FUEL DELIVERY SYSTEMS

GM Vehicle MIL On/Drivability Issues

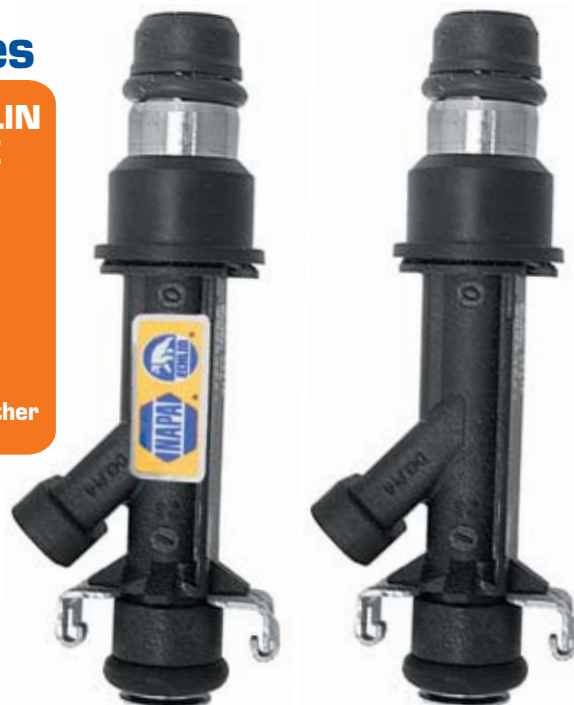
Drivability Symptoms

- Hard start
- Rough idle
- Misfire

Cause of Failure

- Lack of preventive maintenance
- Clogged injector

- Replace fuel injector with NAPA Echlin 2-38765 and use dielectric grease on both of the female terminal cavities
- Regular use of NAPA Echlin Pro Clean™ fuel injection cleaning service

When replacing the fuel injector O-ring, be sure to install the brown O-ring in the lower position. The fuel injector lower O-ring uses a nylon collar called the O-ring backup, to properly position the O-ring on the fuel injector. Be sure to install the O-ring backup, or the sealing O-ring may move on the fuel injector when installing the fuel rail. If the sealing O-ring is not seated properly, a vacuum leak is possible and drivability complaints may occur.
