# Did You Know?

## G.M. Vortec Distributor Issues

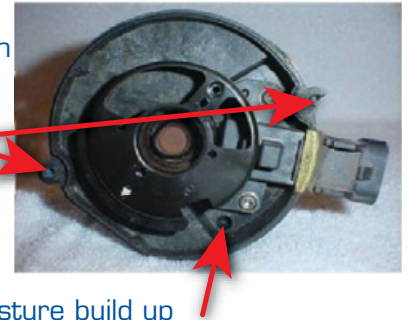
**1. Issue:** The distributor base on G.M. Vortec engines is made from plastic. The distributor cap holding screws use loctite on the threads. NAPA Echlin replacement caps are supplied with new screws which also use loctite. It is very easy to break the mounting tabs on the distributor base if the new screws are forced through the old, hardened loctite.

**Solution:** Always inspect the distributor base before installing the new cap. Clean old loctite from the mounting tab threads and also consider reusing the old cap holding screws.

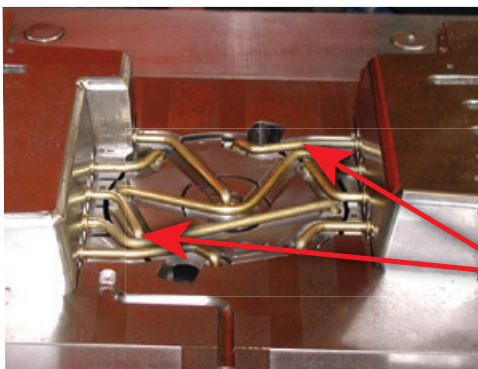
Echlin Brass Conductors prepared for the injection molding process

**3. Issue:** Burn thru issue on O.E. caps. Aluminum conducting rods are susceptible to distortion during manufacturing and corrosion that increases resistance.

- O.E. cap uses aluminum conductors. Prone to corrosion and the soft aluminum conducting rods distort during manufacturing process resulting in premature burn through.
- Echlin cap uses brass conductors which resist corrosion and do not bend during the Injection Molding process.  
**ADVANTAGE:** much longer service life. No burn through.
- O.E. cap burns through in these areas where conductors are in close proximity.

**Solution:** Echlin caps use brass conductors which offer increased resistance to corrosion. In addition brass conductors are less susceptible to distortion during the Injection Molding manufacturing process and therefore less susceptible to the problems with burn through between the conductors.
