Repeated Coil Failure, Jeep 4.0 Liter

EI-004-05

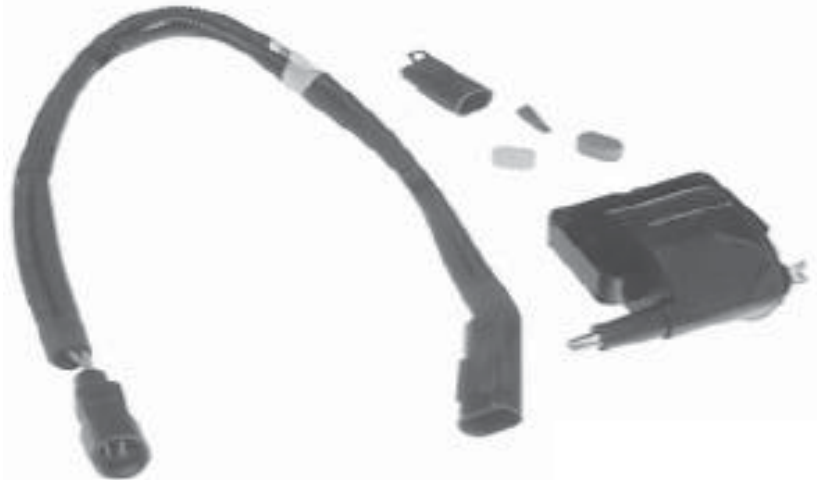
Premature coil failure, or repeated coil failure on 1991-93 Jeep 4.0 liter engines.

On the original O.E. coil, which is similar to a Ford or GM E-core design, the secondary output terminal is very close to the primary circuit terminals. As the vehicle ages secondary ignition KV requirements increase (increased plug gap, increased wire resistance etc.). This also leads to increased primary current draw. Consequently there is increased stress on both the coil secondary and primary circuits. In addition to coil failure this can also lead to PCM failure as the ignition primary circuit is controlled directly by the PCM on these vehicles. Daimler/Chrysler/Jeep has acknowledged this issue with the release of service advisory "08-35-93".

NAPA Echlin has developed an improved ignition coil and resistor harness which notably reduces the build up of heat within the coil and thus the breakdown of insulation and consequent premature failure. The part # is IC 409.
