Water Intrusion and Premature Coil Failure (IC414)

Coils and Water Don't Mix!

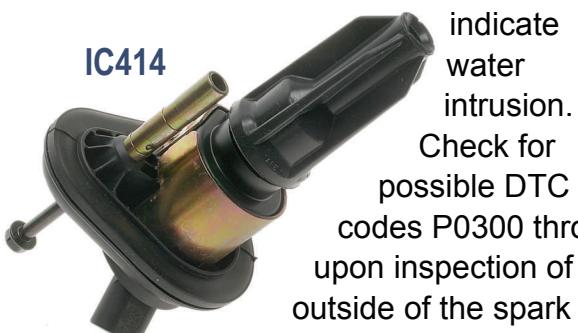
codes P0300 through P0306 and inspect the coils and spark plugs. If upon inspection of the coils, a white chalk like build-up on the inside and/or outside of the spark plug boots is detected, the coils have been damaged and must be replaced—NAPA Echlin hi-quality IC414 coils should be installed.

It is also advised that the spark plugs be replaced.

Water can seep past the engine cam cover and collect below the coils in the spark plug wells of the cylinder head resulting in a possible misfire. To prevent this from reoccurring, the AIP seal must be replaced with a replacement seal that redirects the water away from the engine cam coverer.
