# TECH TIPS

## Replacing Oil-Cooled Turbocharger Center Housing Rotating Assemblies (CHRA)

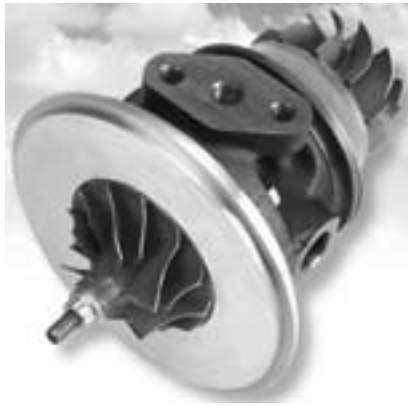
When installing a replacement turbocharger CHRA, keep in mind the main reason for initial failure. In most cases it is caused by a clogged oil inlet line, which results in improper oil flow to the center section, an overheated turbo assembly and ultimately to bearing failure.

So always remember to replace this inlet oil feed line - not just clean, but replace. Then inspect and thoroughly clean the return line. Both of these operations must be done before installation on the engine.

Remove any foreign objects that may have been left in the turbo air inlet or exhaust pipes. When all is cleared, align the end housings to the new center section and torque to specification. Prime the center bearing of the new center section with clean engine oil through the oil feed inlet. Always change the inlet air filter as well as the engine oil and filter when replacing a
