Did You Know?

NAPA Echlin—Jeep Coil Bar

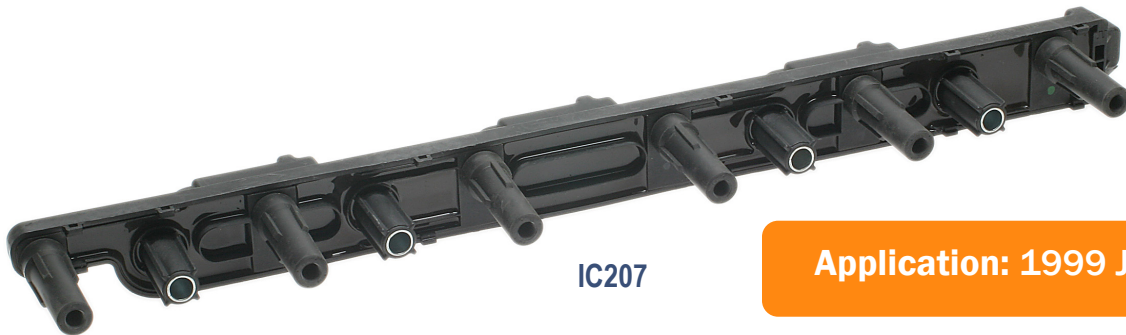
IC207

The Jeep coil bar is a **one piece** coil assembly containing three (3) individual coils.

The coil rail must be replaced as an assembly. The bottom of the coil bar is equipped with six individual spark plug boots which are a permanent part of the coil and are not serviced separately.

The coil is bolted directly to the cylinder head. One electrical connector connects all three coils.

Application: 1999 Jeep

Caution: Inspect the ignition coil bar for cracks and any signs of arcing. Arcing at the secondary end will cause the rubber boots to carbonize which can cause the coil to fail. Replace coil bar if any cracks or signs of arcing are found. **Primary specs only .71 - .88 Ohms**

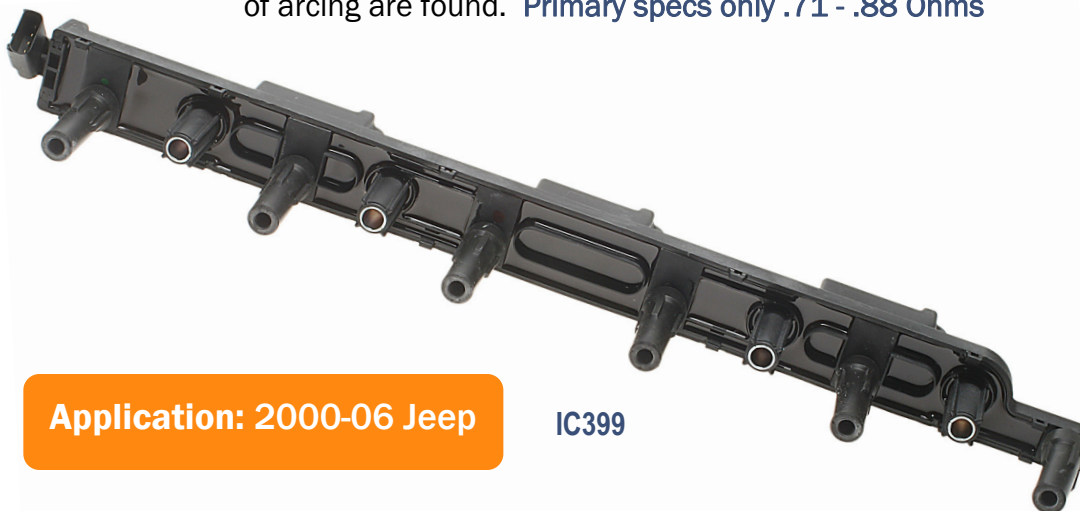
IC399

Application: 2000-06 Jeep
