# Did You Know?

## Improvements to NAPA Echlin GM 6 & 8 Cyl. Caps

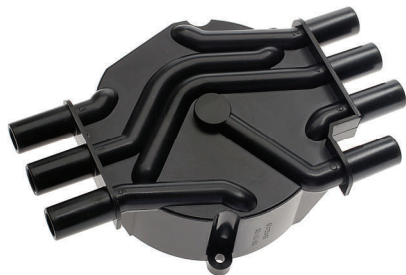
For a long time GM has admitted a design problem with the ignition systems that use the RR207 and RR253 distributor caps. These GM distributor body design flaws have led to premature corrosion of the cap & rotor and ignition system failure due to improper ventilation.

Corroded Brass Terminals

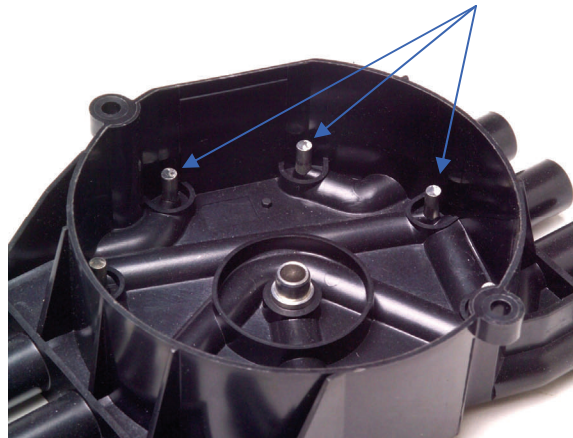
New Aluminum Terminals

NAPA Echlin has made the following improvements to compensate for the faulty OE design. Both the RR207 and RR253 will now be manufactured with aluminum terminals. Due to the OE distributor flaws and corrosive environment, in these instances, aluminum will actually provide a longer service life than the brass. Additionally, both numbers will now use a special formulation manufactured from a polyester base plus a unique blend of mica particles and glass fibers. This improvement results in superior performance due to the higher dielectric strength of the cap.
