Did You Know?

NAPA ECHLIN FUEL INJECTORS OFFER THE QUALITY AND RELIABILITY ESSENTIAL FOR TODAY'S ADVANCED FUEL DELIVERY SYSTEMS

GM Vehicle MIL On/Drivability Issues

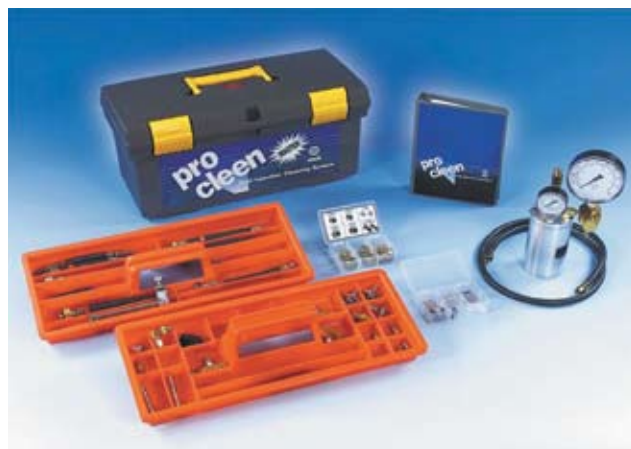
Drivability Symptoms

- Hard start
- Rough idle
- Misfire

Cause of Failure

- Lack of preventive maintenance
- Clogged injector

- Replace fuel injector with NAPA Echlin 2-38765 and use dielectric grease on both of the female terminal cavities
- Regular use of NAPA Echlin Pro Clean™ fuel injection cleaning service

When replacing the fuel injector O-ring, be sure to install the brown O-ring in the lower position. The fuel injector lower O-ring uses a nylon collar called the O-ring backup, to properly position the O-ring on the fuel injector. Be sure to install the O-ring backup, or the sealing O-ring may move on the fuel injector when installing the fuel rail. If the sealing O-ring is not seated properly, a vacuum leak is possible and drivability complaints may occur.

Whenever a portion of the fuel system has been removed you must check for fuel leaks. To do this, turn the ignition on for 2 seconds, off for 10 seconds, then back on again. Now check all connections for leaks.
