Did You Know?

NAPA Echlin Camshaft/Crankshaft Position Sensors

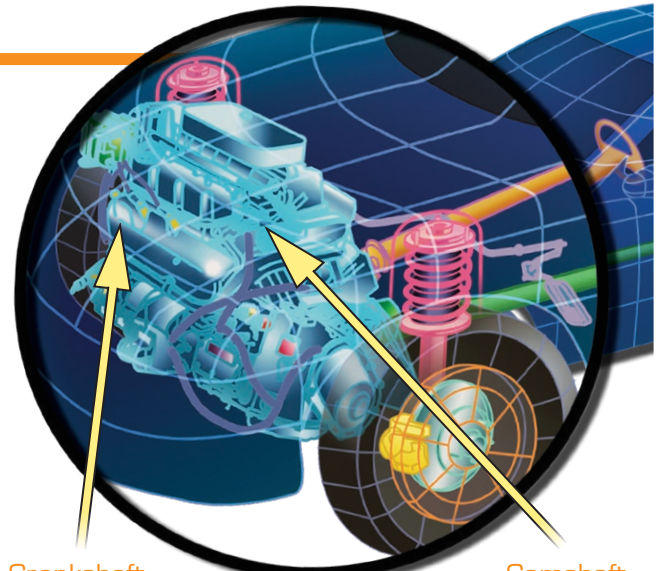
The Camshaft Position sensor is typically located in the cylinder head of the engine and has a cylindrical portion that inserts into the head. The Crankshaft Position sensor is normally located in the timing cover or on the side of the block with a cylindrical portion that inserts into the block.

Crankshaft Position Sensor

Camshaft Position Sensor
