TECH EXPERT™ DISA Valve Repair Kits

DSA700 / DSA701 / DSA702
BMW 2012-97
VIO over 1.5 Million

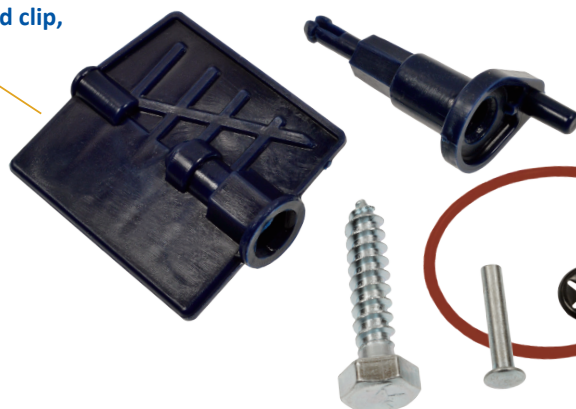
Comes complete with new flap, flap driver, mounting pin and clip, removal screw, and O-ring

Allows you to replace only failed flap instead of full DISA Valve assembly

Our Response: To save customers money, TECH EXPERT's DISA Valve Repair Kits include everything needed to replace only the failed flap instead of the entire DISA valve assembly. Each kit comes complete with a new flap, a flap driver, a mounting pin and clip, a screw to assist with removing the damaged unit, and an O-ring to prevent vacuum leaks.

TECH EXPERT™ Tip: When installing a DISA valve that has new components, use caution and make sure the vacuum lines and electrical connector are connected. Also, clear stored memory if any trouble codes were stored or any drivability issues are noticed.
