Tech Expert™ High Pressure Fuel Pump Cam Follower

Tech Expert™ now offers a high-quality direct replacement High Pressure Fuel Pump Cam Follower for 2013-2006 VW/Audi 2.0T.

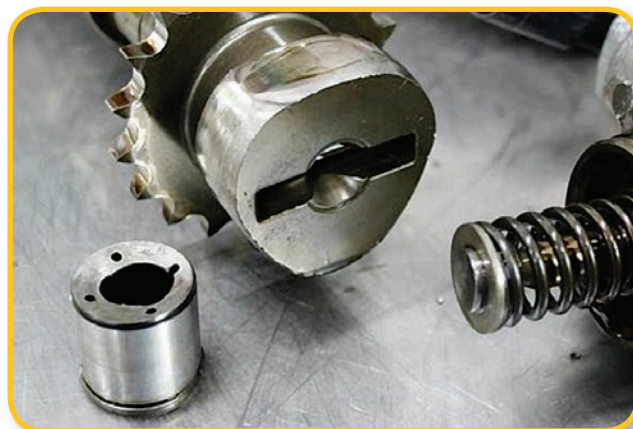
The low-friction coating on the original units can wear down over time causing excess friction against the cam lobe and high-pressure fuel pump plunger. This can lead to extreme engine damage and an expensive repair. Checking and replacing the cam follower with the Tech Expert™ CMF700 will save money in the long run.

Catastrophic Failure

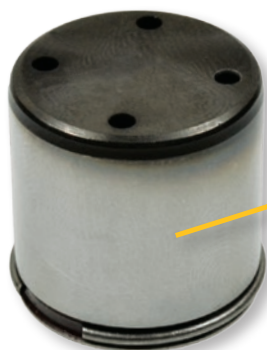
New
Tech Expert™
CMF700
