Did You Know?

Bottom Feed Injectors Removal and Installation Procedures

EC004-05

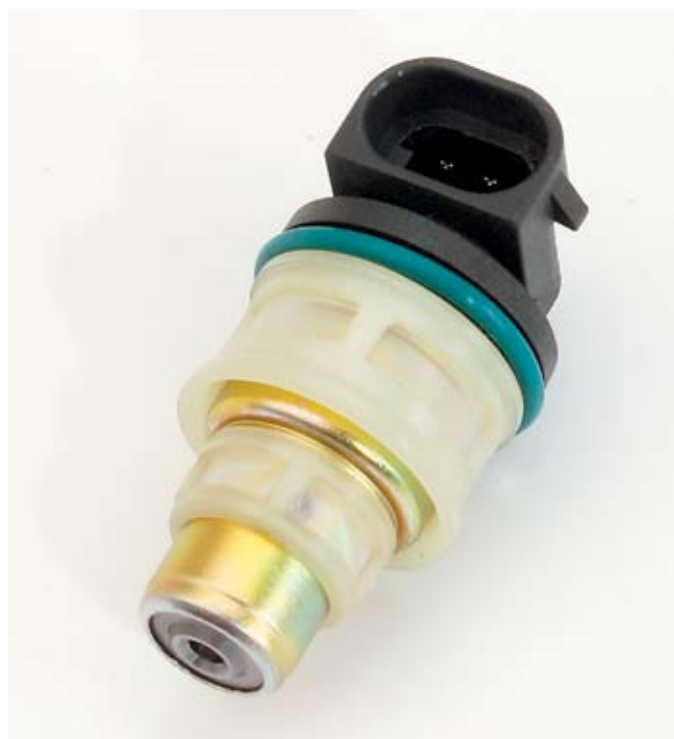
- When replacing bottom feed injectors all removal and installation procedures must be followed to prevent engine damage due to hydrostatic lock-up
- Special attention must be taken to ensure that all o-rings are installed properly prior to installation
- Bottom feed injector must be installed carefully. Improper installation can damage the o-rings resulting in un-regulated fuel entering the cylinder causing hydrostatic lock.
- AFTER injector replacement BEFORE engine cranking, a fuel system leak test must be performed to verify that the injectors are not leaking.
- If the fuel system does not hold pressure the engine must NOT be cranked over
- Determine what has caused the fuel press leak-down. Repair, and then perform the injector leak-down test. Repeat until the system holds pressure.

Caution: To prevent possible engine damage this procedure must be followed.

Reference the NAPA Echlin fuel injection cleaning manual for fuel system pressure check.
