**DID YOU KNOW?**

## GM "T" Shaped Battery Cable Bolt

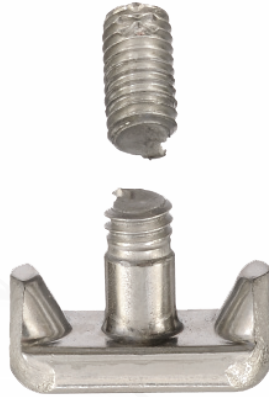
The battery cable bolts used on late model GM trucks have low torque specifications. As a result, they break easily during routine servicing. In the past, the broken bolt was commonly repaired in one of three ways: purchasing a new OE bolt from the dealer, installing a universal-style emergency terminal, or using a hose clamp. However, the dealership bolts can be expensive, the universal terminals are not a direct fit, and the hose clamp repair is temporary and unprofessional.

**Broken OE Bolt**

With the NAPA® Echlin® GM-style "T" Shaped Battery Cable Bolt, you can replace the broken part with a high-quality, direct-fit replacement without having to go to the dealer.

To prevent breakage, torque the bolt to no more than 5nm/44 in-lbs/3.6 ft-lbs.

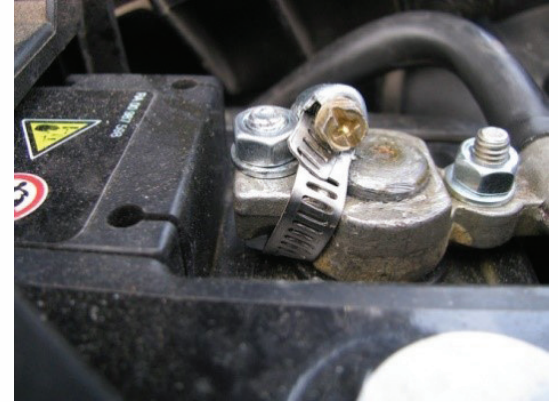
**Temporary Hose Clamp Repair**

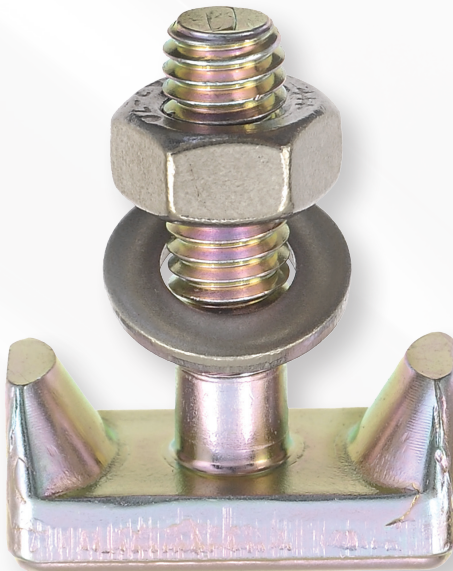
#### **718628**

- 1 per clamshell point-of-sale package
- Includes nut and washer
