DID YOU KNOW?

GM "T" Shaped Battery Cable Bolt

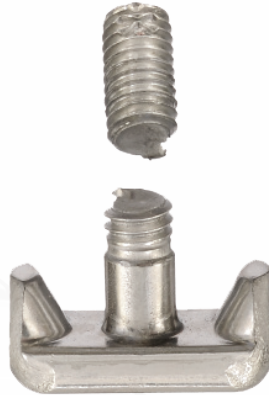
The battery cable bolts used on late model GM trucks have low torque specifications. As a result, they break easily during routine servicing. In the past, the broken bolt was commonly repaired in one of three ways: purchasing a new OE bolt from the dealer, installing a universal-style emergency terminal, or using a hose clamp. However, the dealership bolts can be expensive, the universal terminals are not a direct fit, and the hose clamp repair is temporary and unprofessional.

Broken OE Bolt

With the NAPA® Echlin® GM-style "T" Shaped Battery Cable Bolt, you can replace the broken part with a high-quality, direct-fit replacement without having to go to the dealer.

To prevent breakage, torque the bolt to no more than 5nm/44 in-lbs/3.6 ft-lbs.

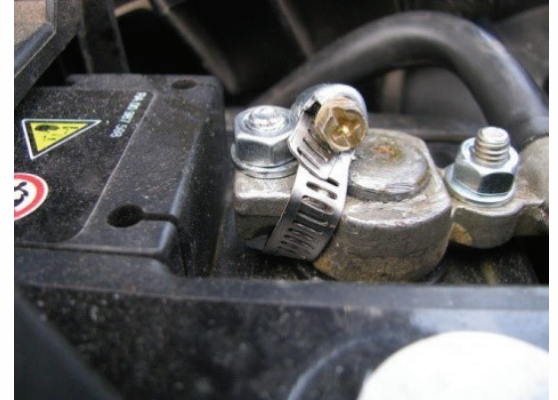
Temporary Hose Clamp Repair

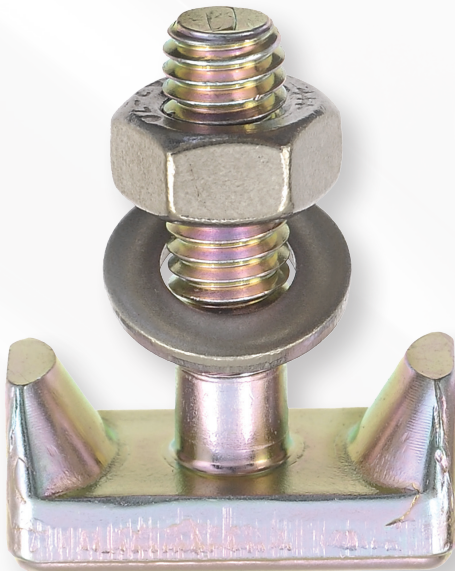
718628

- 1 per clamshell point-of-sale package
- Includes nut and washer
